EASA	AIRWORTHINESS DIRECTIVE
 	<p>AD No.: 2009-0233</p> <p>Date: 28 October 2009</p> <p>Note: This Airworthiness Directive (AD) is issued by EASA, acting in accordance with Regulation (EC) No 216/2008 on behalf of the European Community, its Member States and of the European third countries that participate in the activities of EASA under Article 66 of that Regulation.</p>
<p>This AD is issued in accordance with EC 1702/2003, Part 21A.3B. In accordance with EC 2042/2003 Annex I, Part M.A.301, the continuing airworthiness of an aircraft shall be ensured by accomplishing any applicable ADs. Consequently, no person may operate an aircraft to which an Airworthiness Directive applies, except in accordance with the requirements of that Airworthiness Directive unless otherwise specified by the Agency [EC 2042/2003 Annex I, Part M.A.303] or agreed with the Authority of the State of Registry [EC 216/2008, Article 14(4) exemption].</p>

<p>Type Approval Holder's Name :</p> <p>None</p>	<p>Type/Model designation(s) :</p> <p>AS 202 "Bravo" aeroplanes</p>
SAS Number :	EASA SAS.A.067
Foreign AD :	Not applicable
Supersedure :	This AD supersedes AD 2009-0177 dated 05 August 2009
ATA 28	Fuel – Fuel

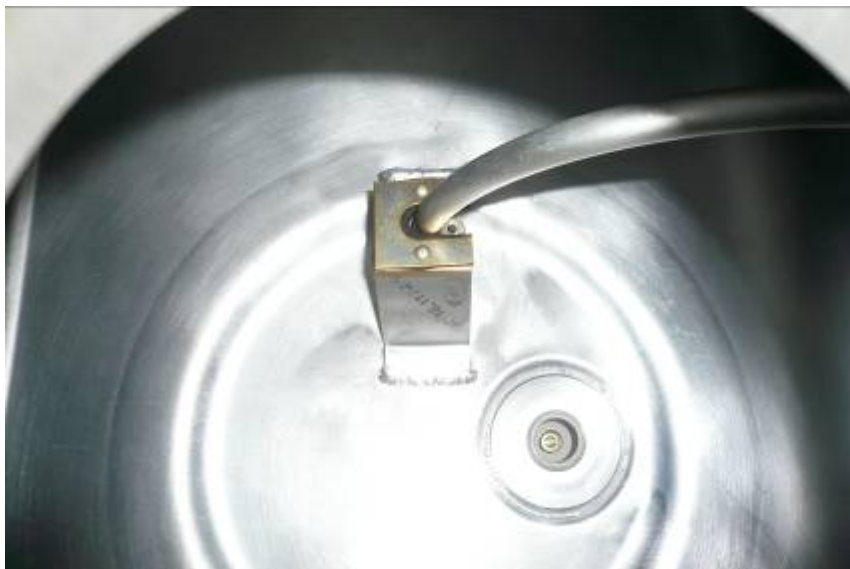
Photo 1

Area to be inspected as seen from top of the fuel tank with Fuel level sensor P/N SA 210-08095-01 removed

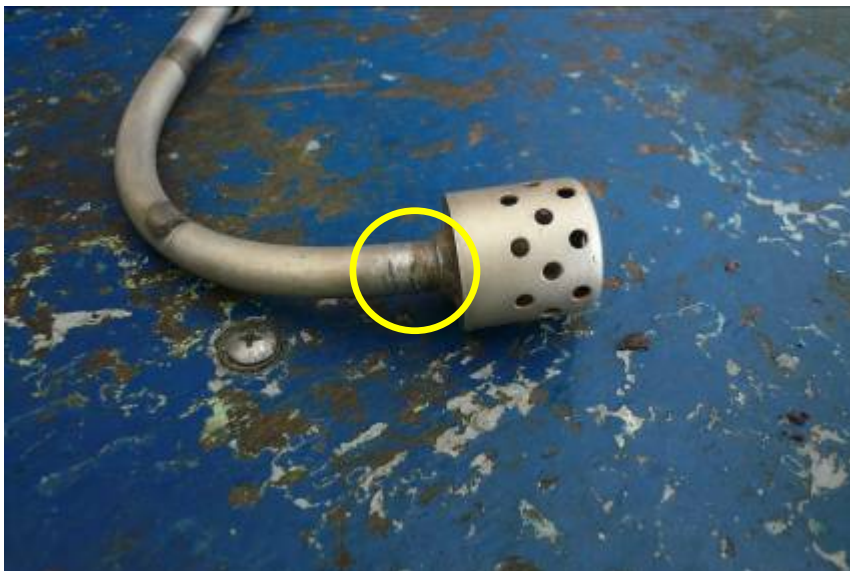
Photo 2

Example of signs of damage on Fuel suction tube assembly P/N SA202-18112-07
